INTERNATIONAL CONFERENCE of SCIENTIFIC PAPER AFASES 2011 Brasov, 26-28 May 2011

CONCERNS OVER FLIGHT PARAMETERS INTERPRETATION IN ORDER TO IDENTIFY THE CAUSE – EFFECT CONNECTION IN FLIGHT OCCURRENCES

To illustrate how the interpretation of an aircraft flight parameters may help identify the immediate cause of the flight occurrence, we chose Puma helicopter one.

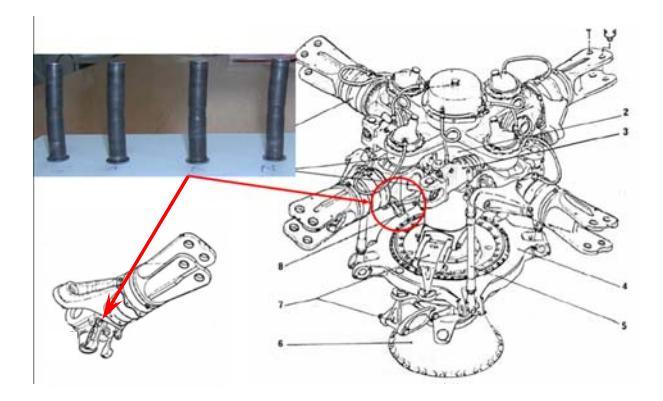
After the final landing and the engines stop, it was found that the main rotor blades descend too much and the inferior automatic limiters remained in the unlocked position.

The helicopter was moved to the repair shop, the main blades were lifted in normal position and it was found that the inferior automatic limiters return to initial position only by applying a considerable force. Consequently, for further technical investigations the main blades were removed and the articulated axles of the inferior automatic limiter were examined.

Deformations of the articulated axles were found, the maximum bending-deflections values being exceeded (fig. no 1), and the teflon bushings inside the bores limiters were damaged.

Fig. no 1 – Deformations of the articulated axles of the inferior automatic limiters. Location on the helicopter main rotor.

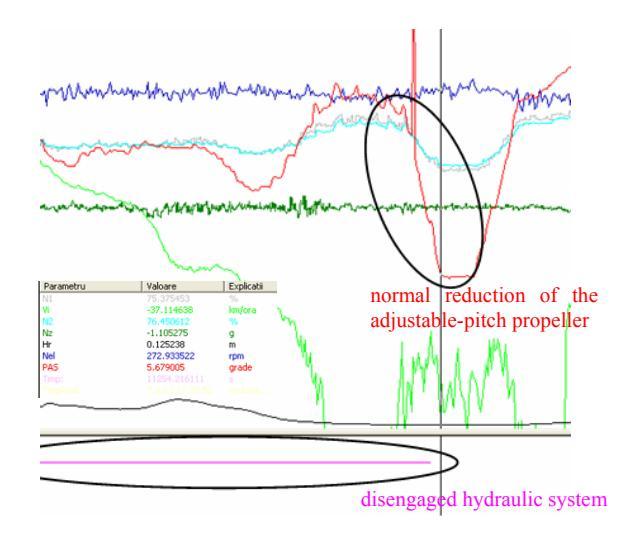
a) Landing procedure with disengaged hydraulic system was executed correctly (fig. no 2). To achieve the landing the adjustablepitch propeller value (P) was reduced in a period of time $\Delta T = 9$ seconds from P = 12 to P = 5.6, the vertical acceleration coefficient being Nz = 1. The engines rotation speed decreased from 88% to 76 % value.

Fig. no 2 – Normal landing with disengaged hydraulic system

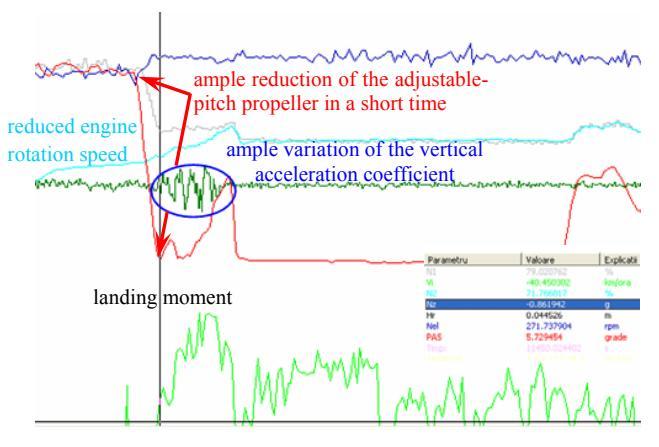
b) With right engine decreased, landing with taxiing was made under the following parameters: adjustable-pitch propeller value was reduced in a period of time $\Delta T = 3s$ from P = 12 to P = 5.6. The left engine rotation varied during this time between N1 = 95% and N1 = 78% values.

Ample reduction of the adjustable-pitch propeller, in a short time, led to a hard landing and this was the cause of the vibrations that were felt in the helicopter main rotor hub and also in the whole structure. The vibrations are visible on the flight parameters recorded, in the ample, unnatural variation of the vertical acceleration coefficient Nz (fig. no 3), which had values between Nz = 0.6 and Nz = 1.5, for a period of time $\Delta T = 9s$. A further proof for the vibrations cause is that they stop when the adjustable-pitch propeller value increases (during the aircrew command) to P = 8.5. The end vibrations moment coincides with the

moment when the engine rotation speed is commanded to normal value.

Fig. no 3 – The hard landing

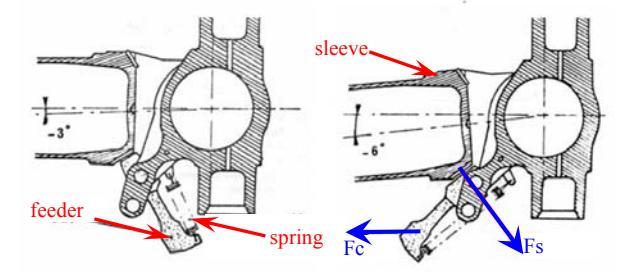
Due to the ample reduction of adjustablepitch propeller value, the main rotor blades had a forceful beat movement, the main rotor sleeves hitting the inferior automatic limiter feeders (fig. no 4) and forcing (under the Fs force action) the articulated axles to be deformed. The pitch articulation sleeve is equipped with a limiter which stops the blades to descend under a constant value, when the engines stop (in order to protect the tail beam ensemble).

The articulated axles being deformed, the limiters springs can not longer bring the feeders in the locked positions, thus, when the engines stop, in the absence of centrifugal force, the sleeves descend to the fixed limiters level, and therefore the blades descend over the normal position.

Fig. no 4 – Inferior automatic limiters positions

In fig. 4a the main rotor hub is stopped. The sleeve rests on the contact surface of the two feeders which are pulled by springs. The value of the angle (3^0) between blades and rotor disk is normal.

In fig. 4b the engines are working at normal rotation speed. The centrifugal force (Fc) acts on the feeders which, unlocked, allow the blade to have a beat movement down to the fixed limiters. The value of the angle (6^0) between blades and rotor disk is normal only in a few situations during the flight.
